NAME OF DAM: DALEY DAM  
LOCATION: LOUDOUN COUNTY, VIRGINIA  
INVENTORY NUMBER: VA 10709

PHASE I INSPECTION REPORT  
NATIONAL DAM SAFETY PROGRAM

PHASE I REPORT  
NATIONAL DAM SAFETY PROGRAM

Name of Dam: Daley Dam  
State: Virginia  
Location: Loudoun County  
USGS Quad Sheet: Purcellville, Virginia  
Stream: Tributary to Catoctin Creek  
Date of Inspection: 30 April 1981

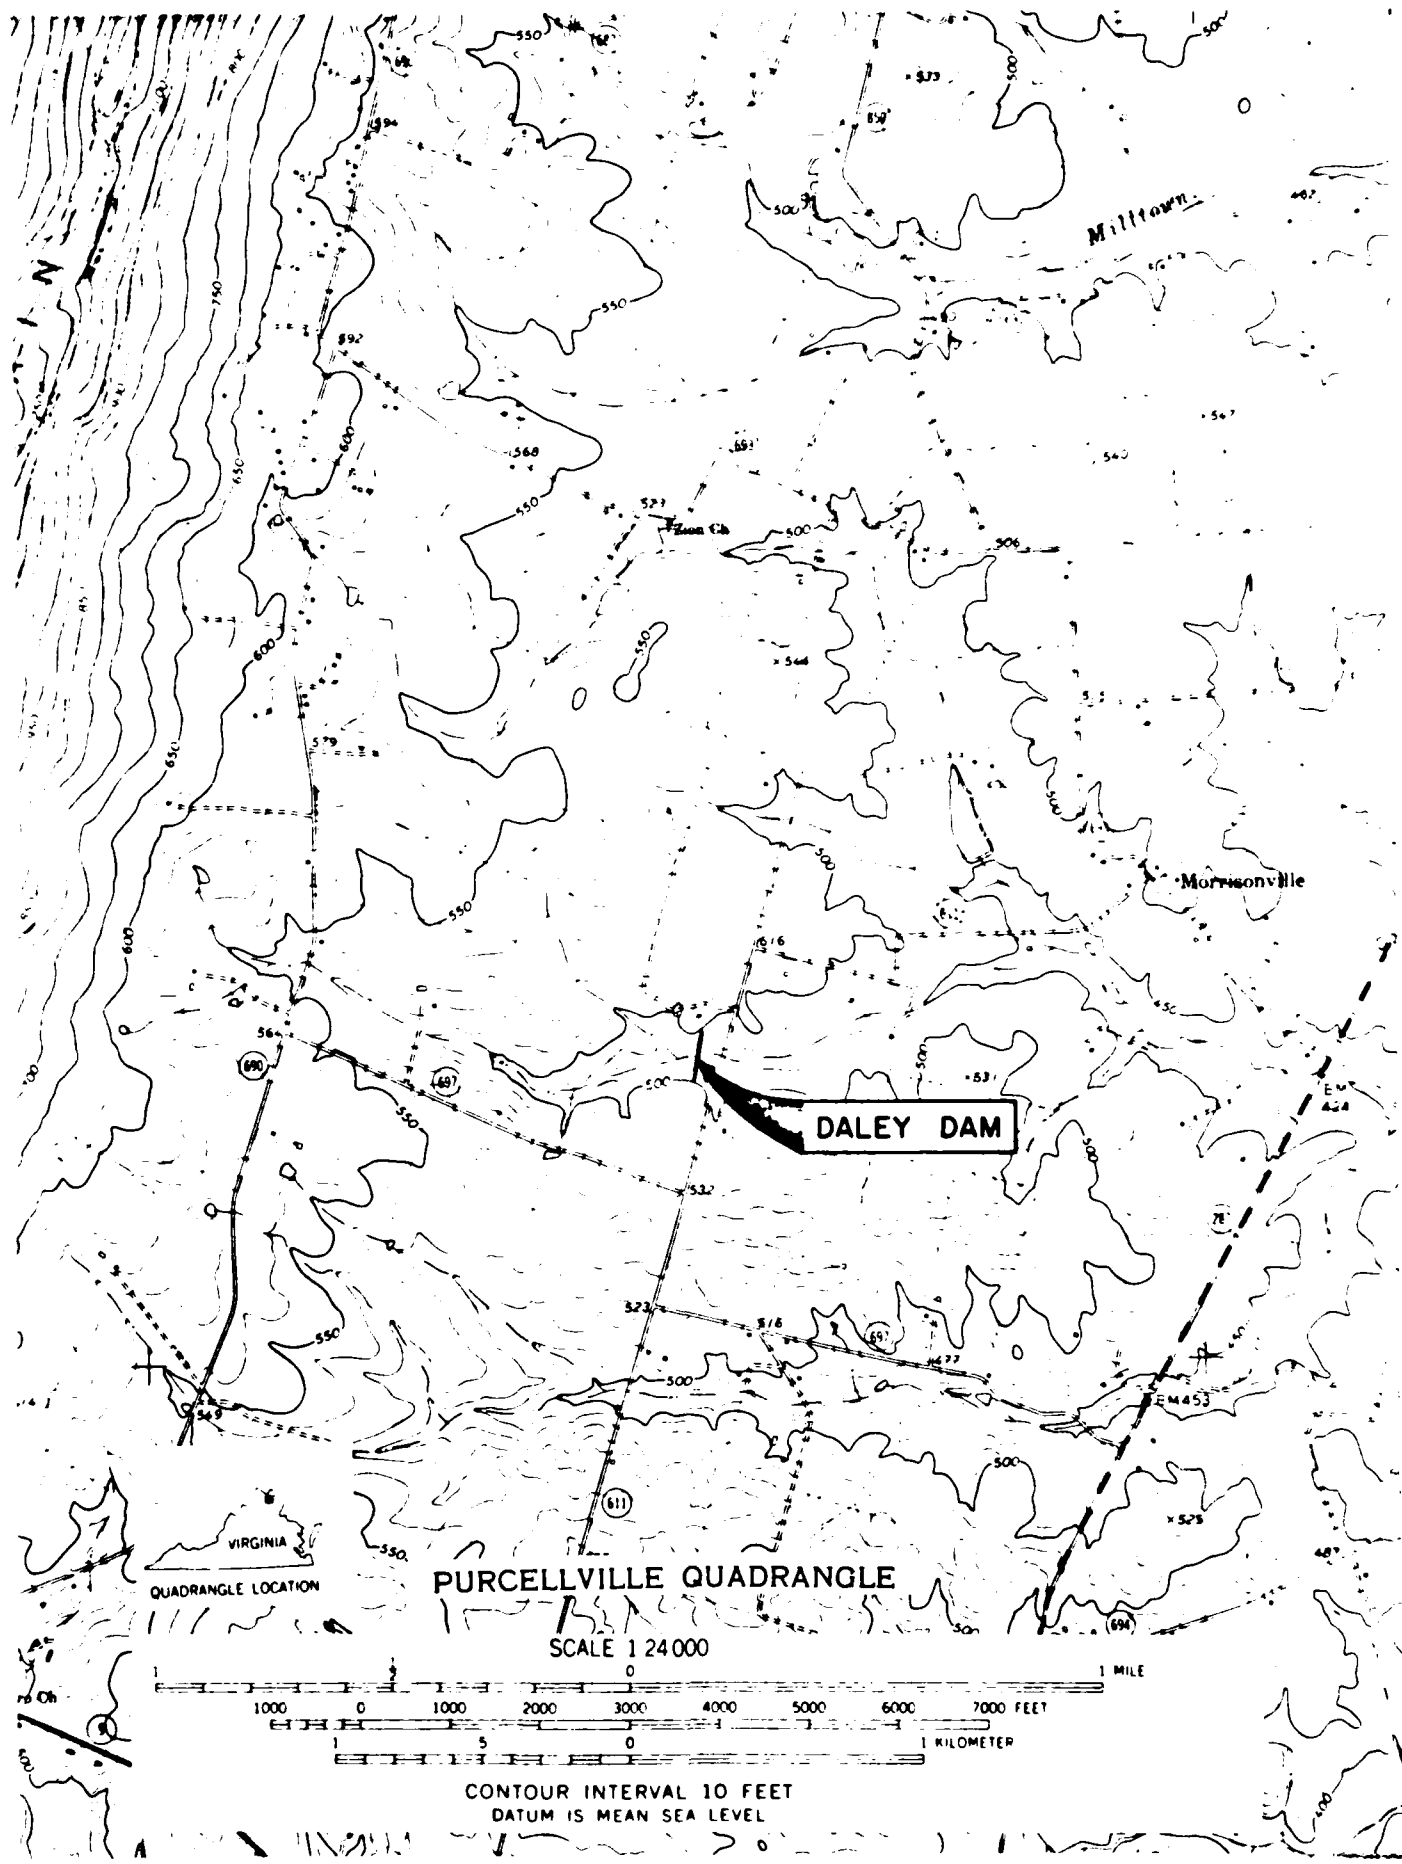
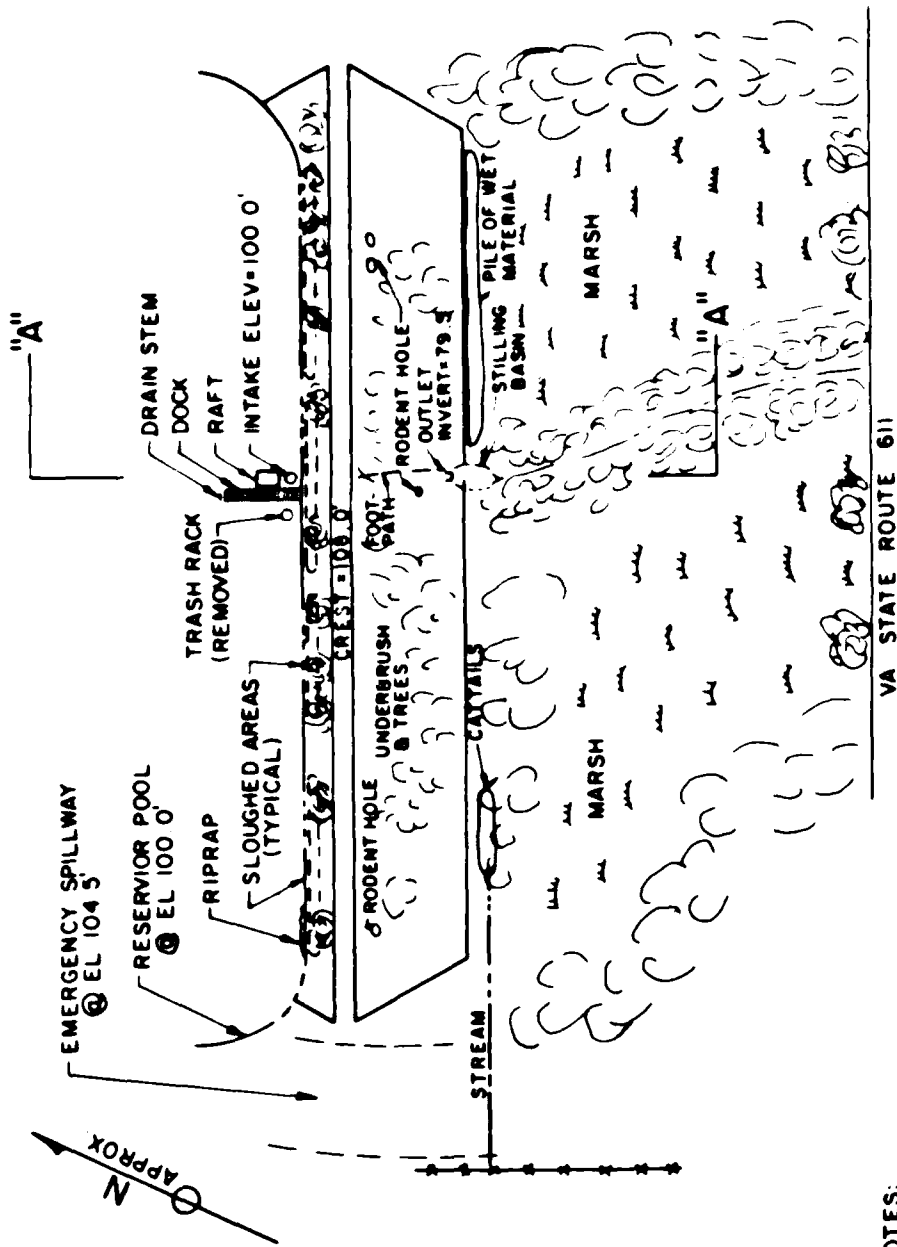
PLATE III

There are no signs of surface cracks, unusual movement, sloughing or misalignment on the crest or downstream face. However, most of the upstream face has experienced slope failure. The failure consists of areas of minor sloughing and areas of large failure surfaces with 4 feet of slip plane exposed. Several footpaths run down both the upstream and downstream faces from the crest. There is minor erosion around the principal spillway outlet pipe. Several animal burrows are located on the downstream face. (See Plate III, Appendix I and Photos No. 2, 3, 4 & 6, Appendix II).

The portions of the upstream slope that have not failed are riprapped. The riprap extends from about 3 feet below pool elevation to about 12 feet up the slope. Evidence of riprap is visible on the slope in the areas of minor sloughing, however, there is no evidence of riprap in the areas of large failure surfaces. Apparently, the whole upstream slope was riprapped but the slope failure carried some of the riprap far enough down the slope, beneath the water surface, to be unobservable (See Plate III, Appendix I).

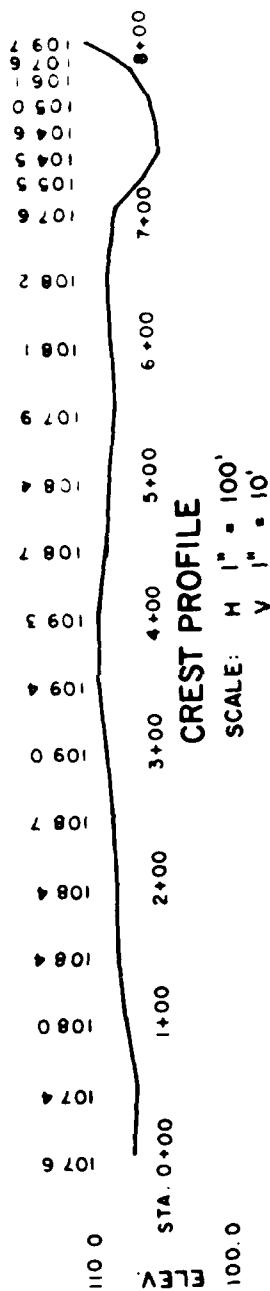
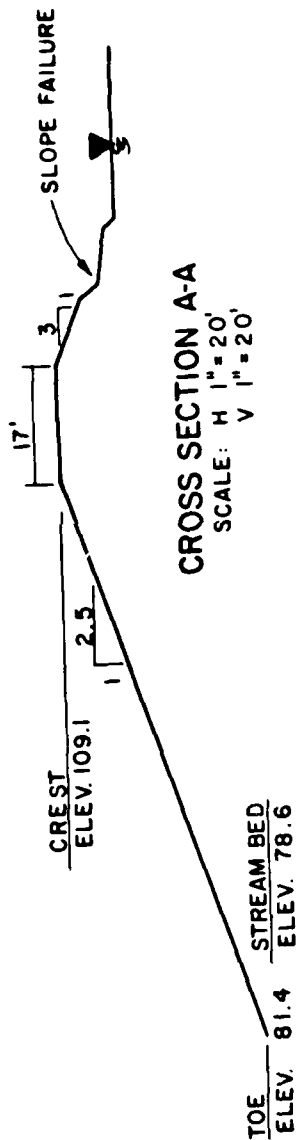
DALEY DAM  
 LOUDOUN COUNT, VIRGINIA  
 30 APRIL 1981  
 PLATE IV

3.1.2 Embankment: The embankment is in fair condition. Sketches showing a plan view, a profile and a cross section at the time of the inspection are provided on Plates III & IV, Appendix I. An overall view of the dam is provided at the beginning of the report.
